European Aviation Safety Agency

Research Project EASA.2008/2

Evaluation of Strength Degradation of Fabric particularly used for Cargo Nets

**“Evaluation of strength degradation of fabric
particularly used for cargo nets”**

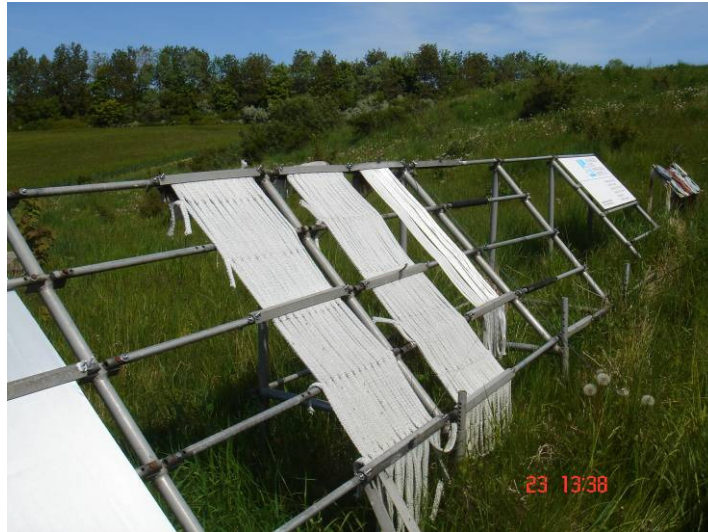
By using the natural exposure, test samples are stored outside for a certain defined time (e.g. in the centre of Europe) and physical parameters (e.g. Climate) are measured during exposure. The exposure time is divided in several parts (e.g. 6, 12, 18, 24 months). At the

Figure 1: Natural exposure area of STF I e.V. – Kap Arkona, Germany

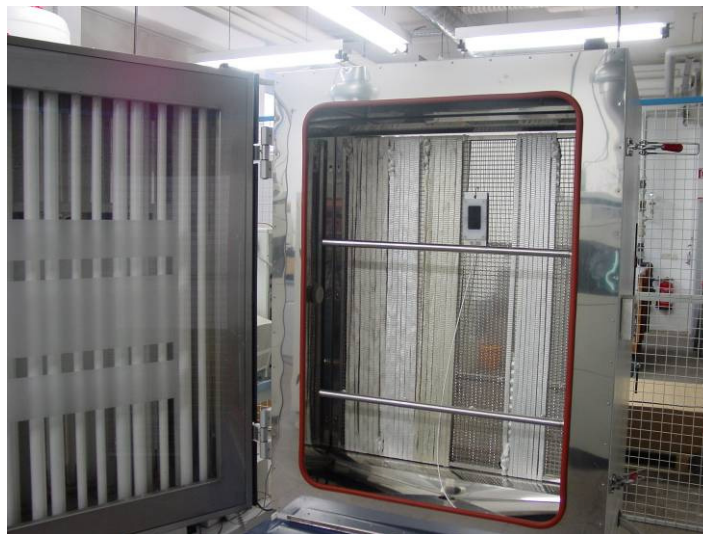
For the artificial weathering special equipment is necessary. This equipment simulates only typical climatic parameters.

Figure 2: UV-Chamber at STF I – simulation of climate

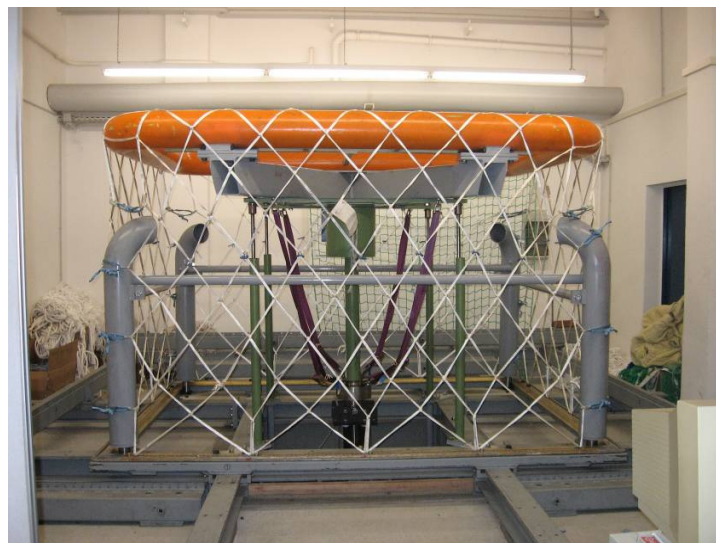
Therefore, STFI developed a net testing method and equipment (see figure 12) to test the complete net according to STFI internal test procedure [24] at full scale test.

Advantages of this full scale test set-up are that all single parts of the net and the interaction of all ropes (braids) will be considered while testing. Also the influence of corner cords (lashing lines) and reefing hooks for shortening have to be considered. The STFI test method does address another essential issue, the interface net to pallet. For attaching the net to the pallet proper fastening elements (double studs) are used to achieve representative load transfer between net and pallet.

Figure 12: Test set-up for air cargo nets (size 96"x125"x118") at STFI e.V., (full scale test)

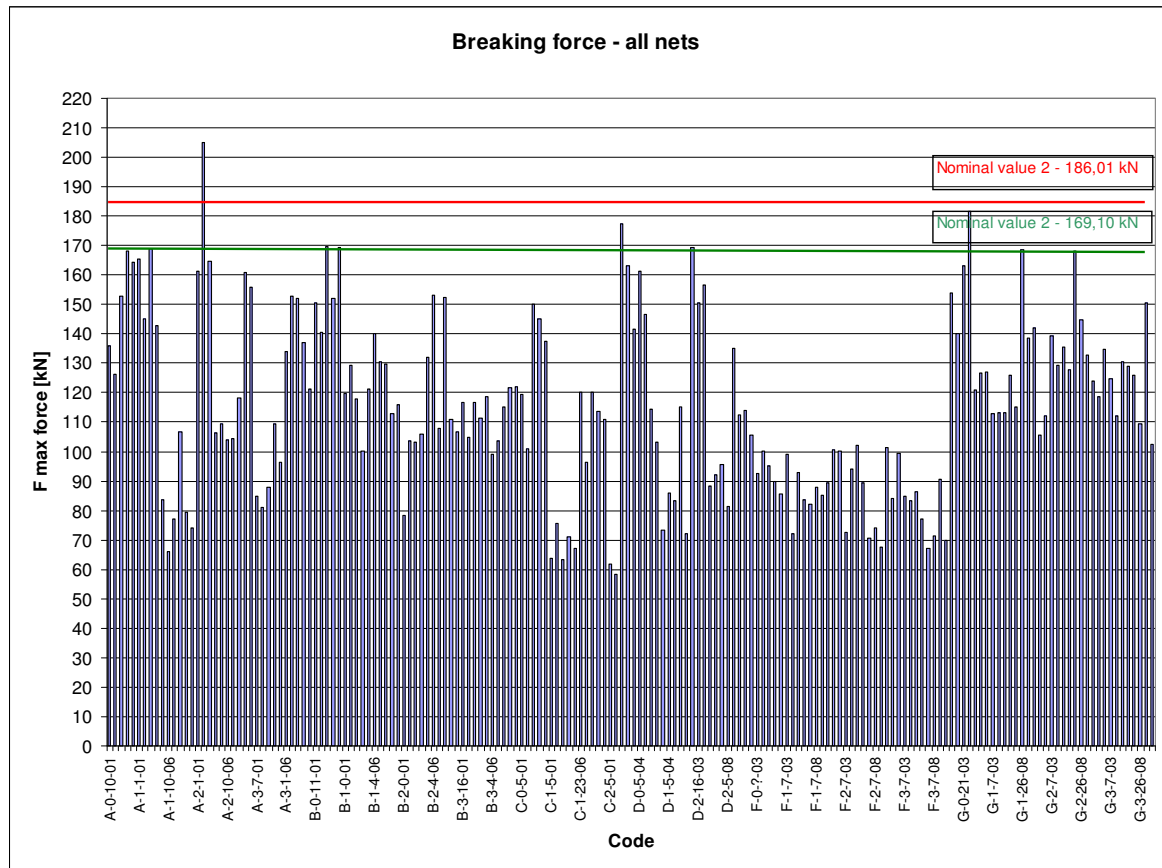
Figure 19: Diagram – Breaking force – all nets

Figure 19 gives a very rough overview of the test results of the tested nets. The next chapter will provide a more specific overview. Out of 180 considered nets only 12 reached the nominal value 1 = 169,1 [kN]. It means only 6,7 % of the tested nets fulfil the NAS 3610 Rev. 10. An overview of all results of the tested nets is shown annex 2. Here all single values and mean values per manufacturer are listed.

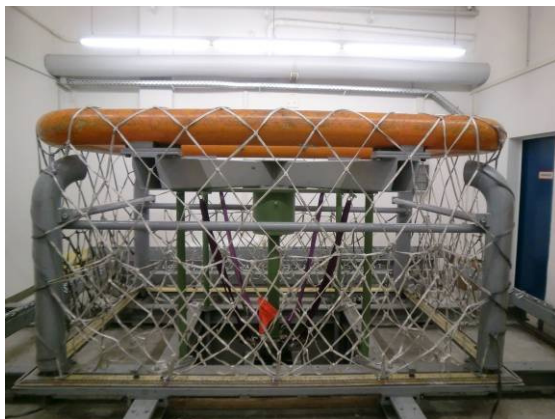
Figure 21: Net 3 years old

The category of different service life time of the nets was chosen to see the influence of the age of the net (new, 1 year, 2 years, 3 years). Each net is labelled with the date of manufacturer (DOM). For this project the service life time of a net was defined as from DOM up to storage in STFI. But it happened that e.g. a 1 year old net did appear to be more used than a 3 years old net (see figures 21, 22).

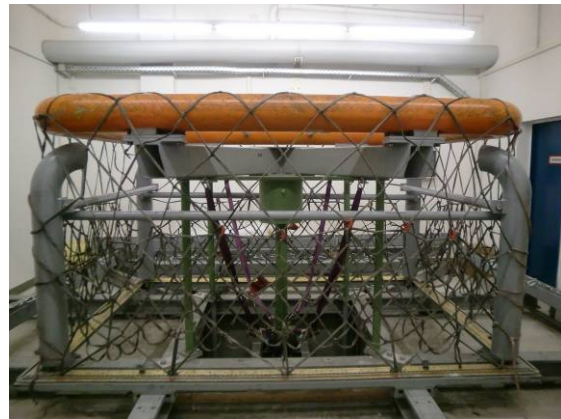
Figure 22: Net 1 year old

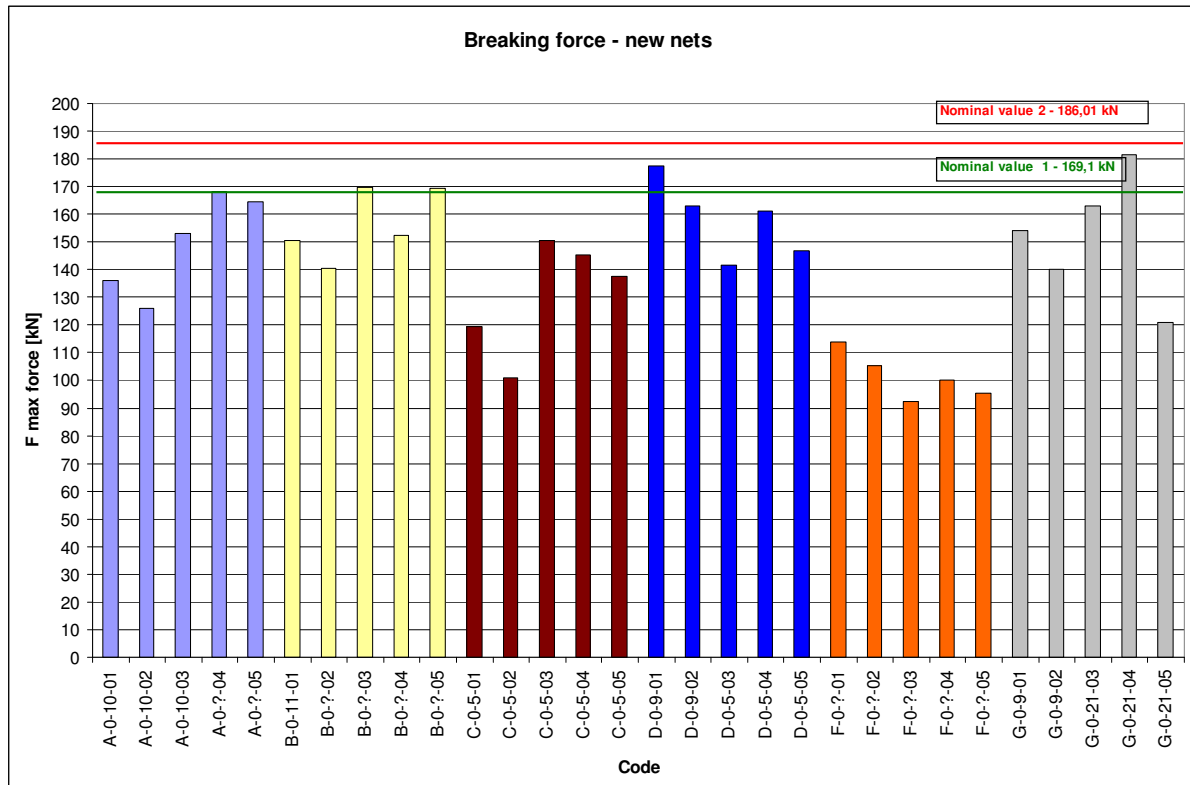
Figure 23: Test results of the new nets

Only 4 of 30 nets reached the nominal value 1 = 169,1 [kN] and no net reached the nominal value 2 = 186,01 [kN] (Safety factor 10% - for 10% load displacement out of centre of gravity).

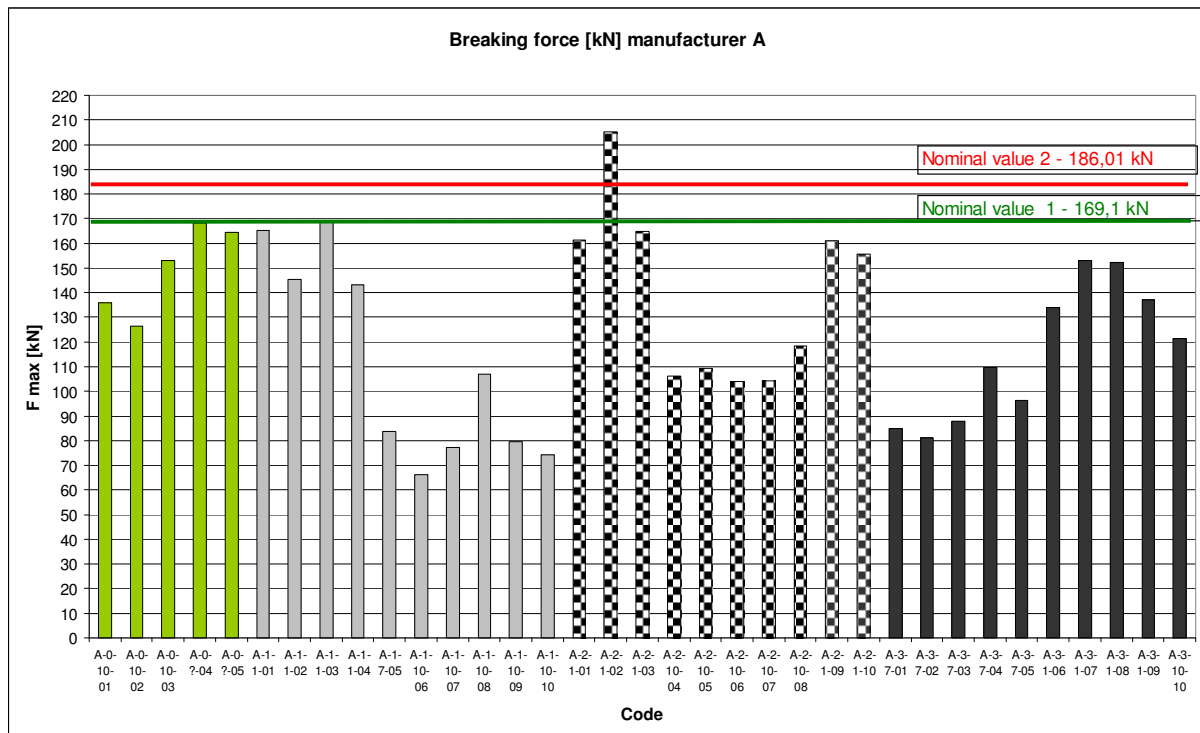
Figure 28: Test results of manufacturer A

The results of manufacturer A are very different. A reason for that is that different P/Ns were tested with different weight of the nets because 3 different part numbers (net variants) had been tested within this group. The nets with the highest weight reached the best load in all categories (new, 1, 2, and 3 years).

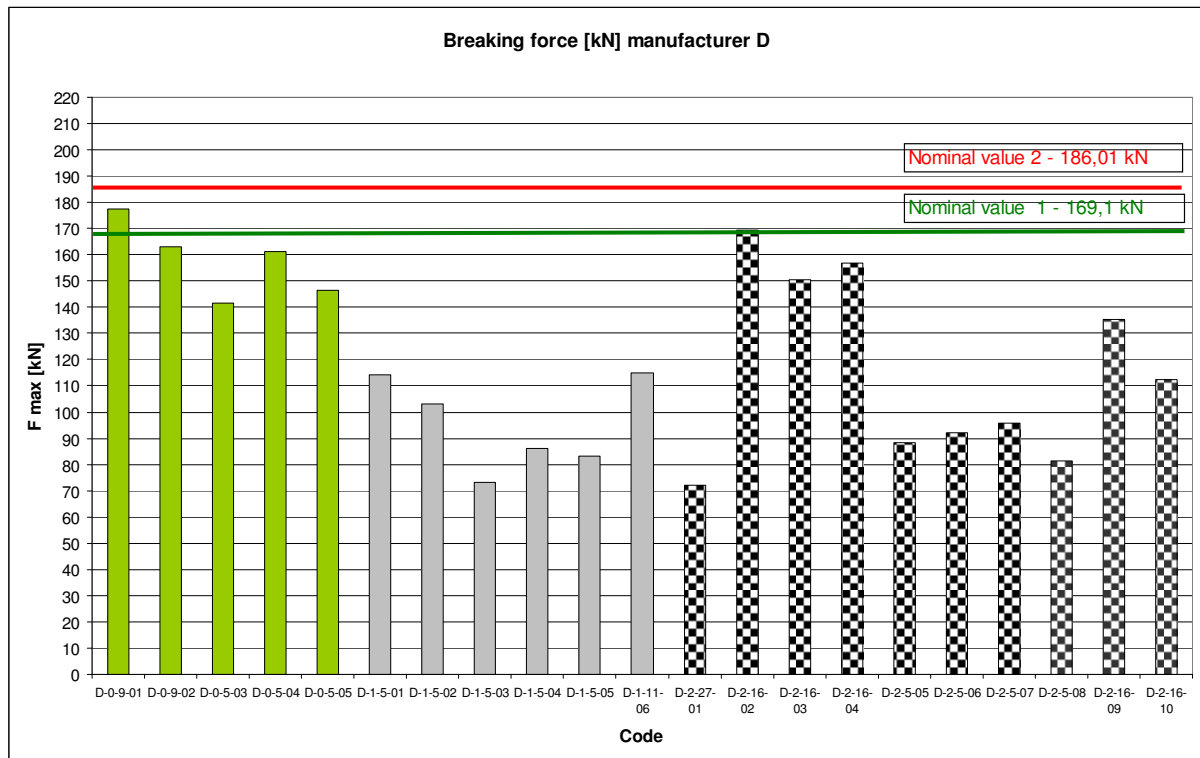
Figure 31: Test results of manufacturer D

Also for manufacturer D the net variant with the highest weight and 24 hooks reached the highest load (new nets specimen 01, 02 and 2 years old nets specimen 02, 03, 04).
